Armaside Wood, Little Asby

Field Barn & Historic Farm Building Surveys

Survey by Paul Gingell, Summer 2019

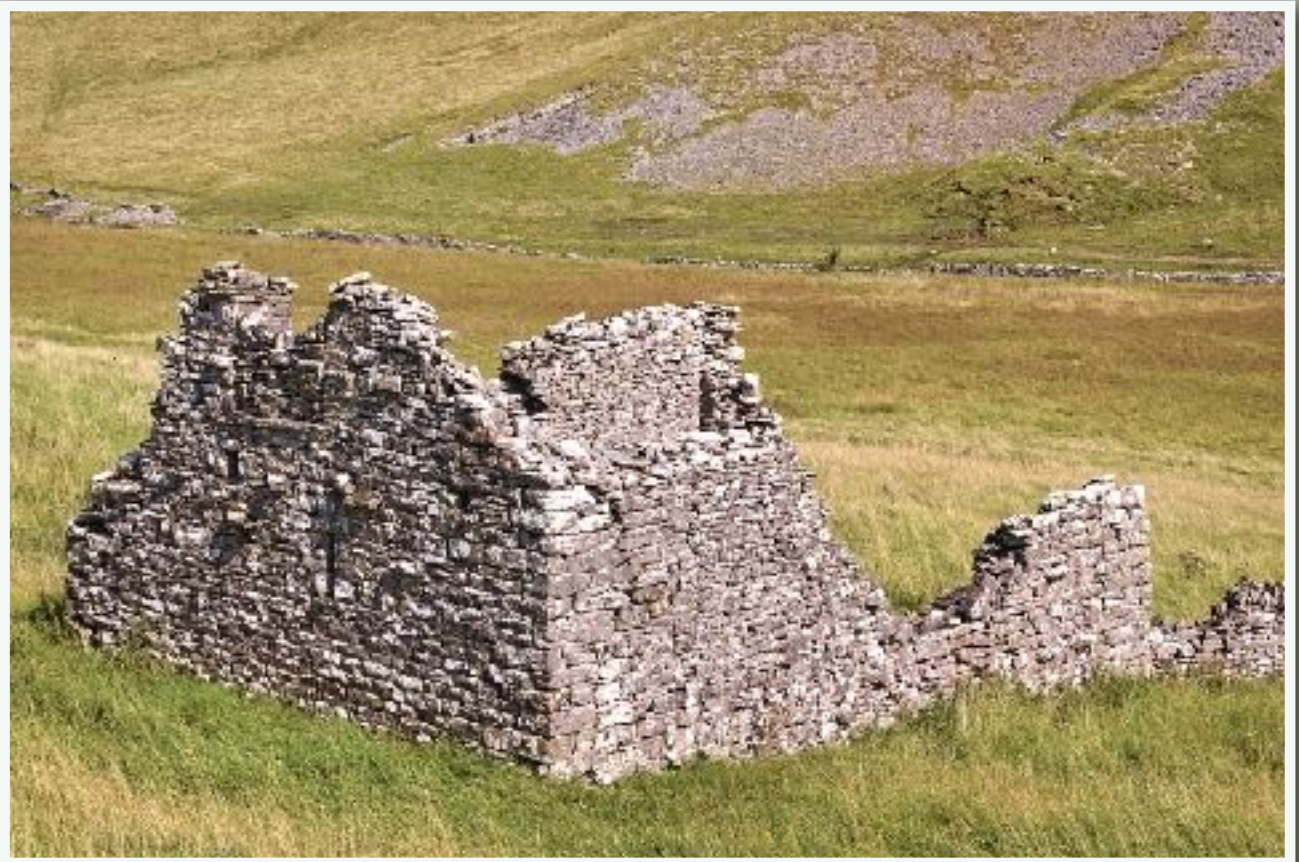
*General view of remaining structure at Armaside Wood,
Little Asby, Cumbria*

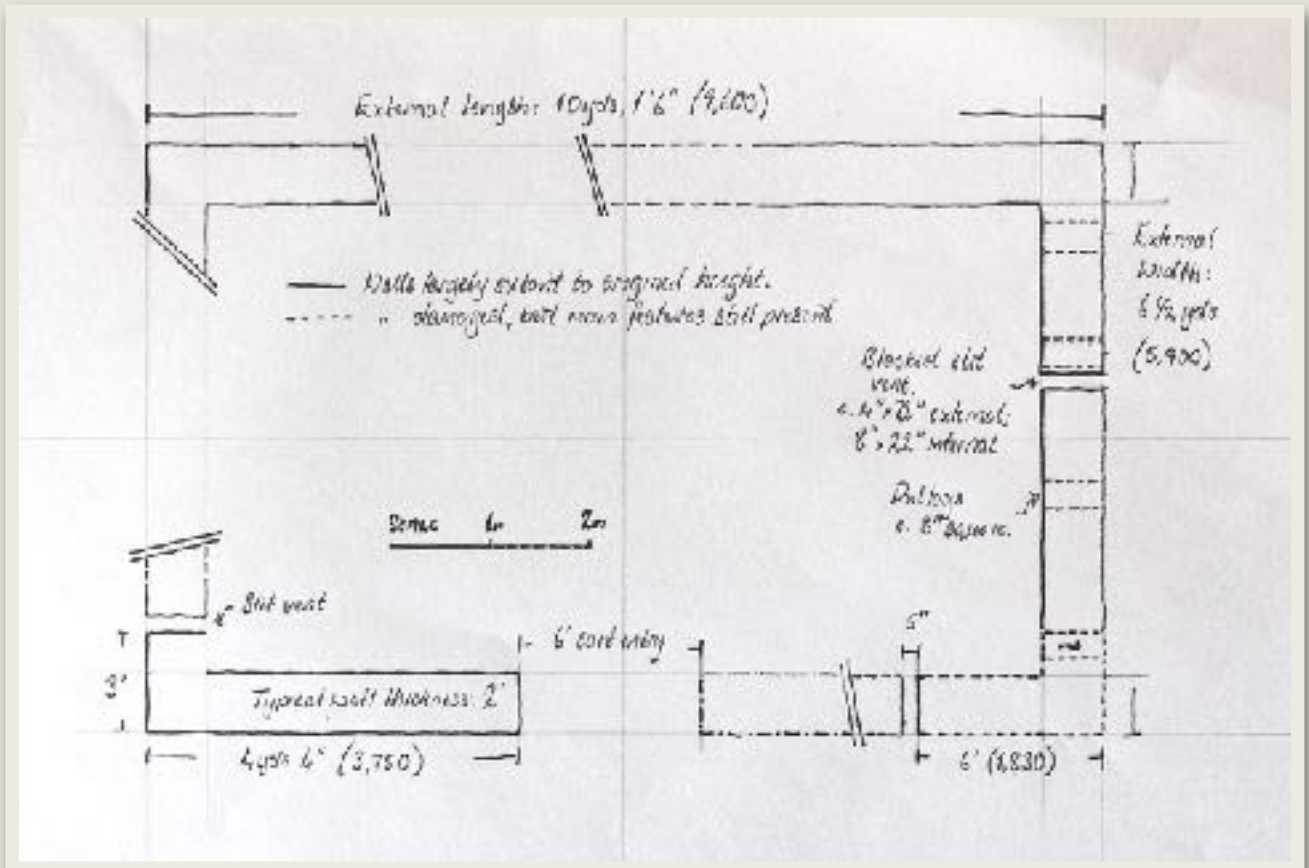
Sketch plan of remaining structure (top); West gable exterior (bottom)

The west gable is the most complete part of the building and contains most of its extant features (including a blocked ventilation slit, putlogs, and forking hole. Partial collapse has occurred, associated with the loss of the adjoining north wall. That structure is important to the stability of the gable, and reconstruction to eaves height would aid its preservation - as would some form of capping of the wall heads.

Soft capping a dry-built structure could prove difficult. Lead capping might be feasible.

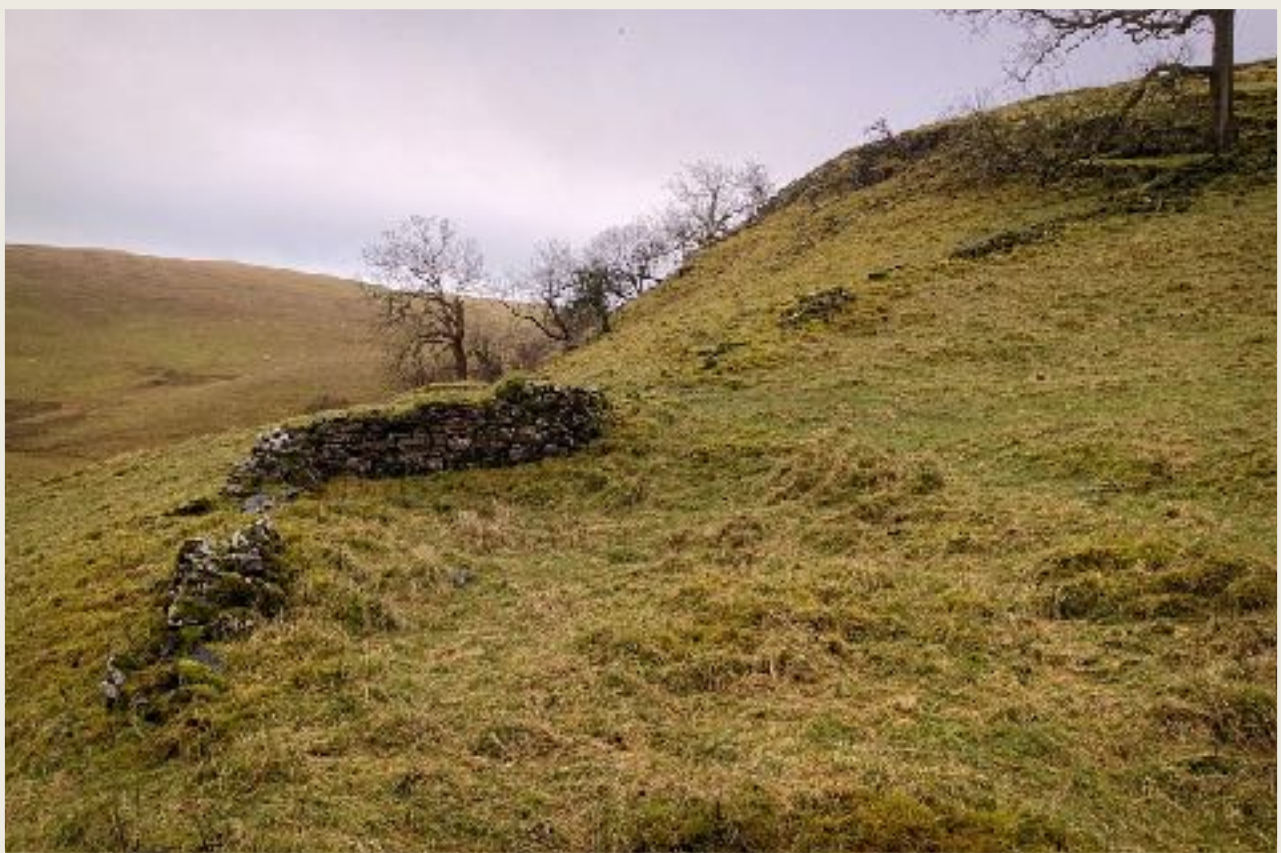
Rectangular structure marked by fragmentary walls and earth works, immediately south of barn.

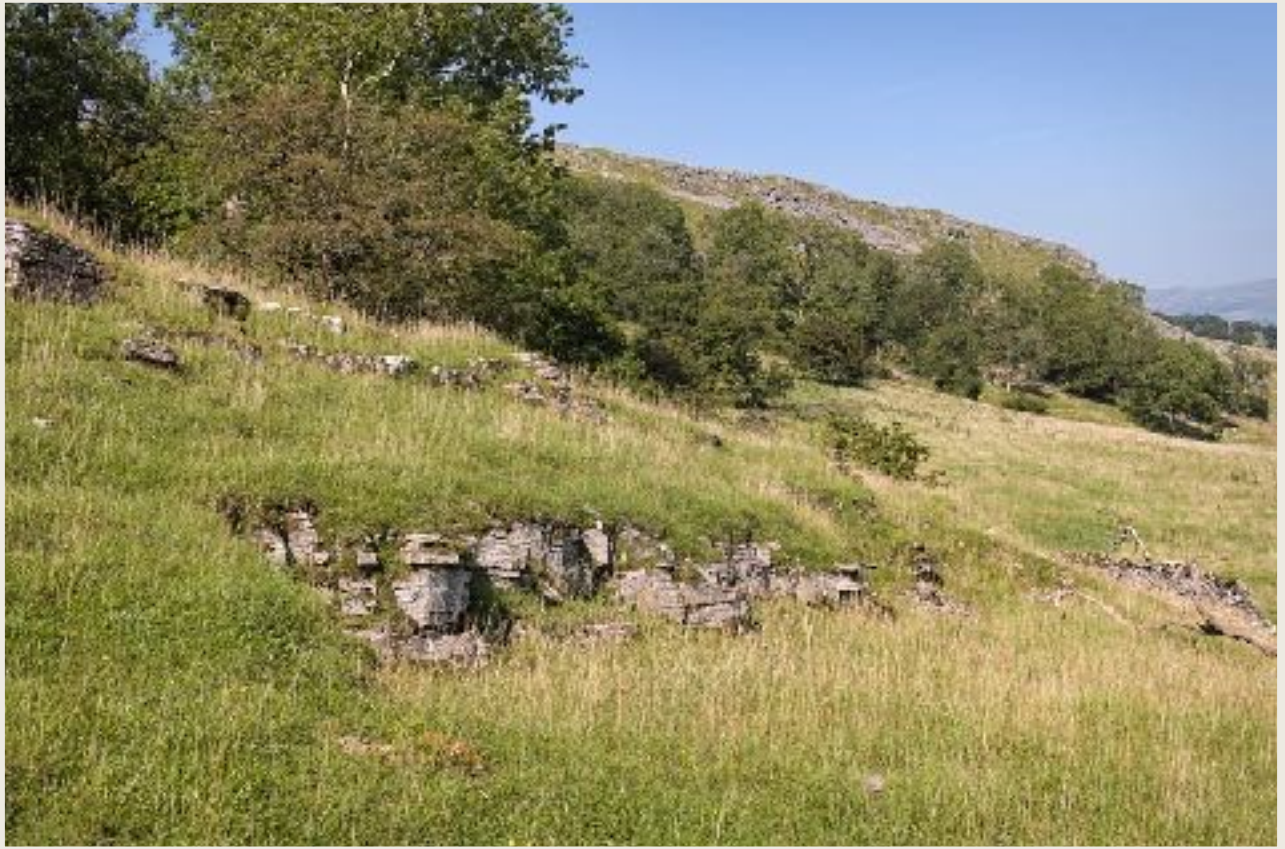
Probably stone source above site (top); General position in landscape (bottom)

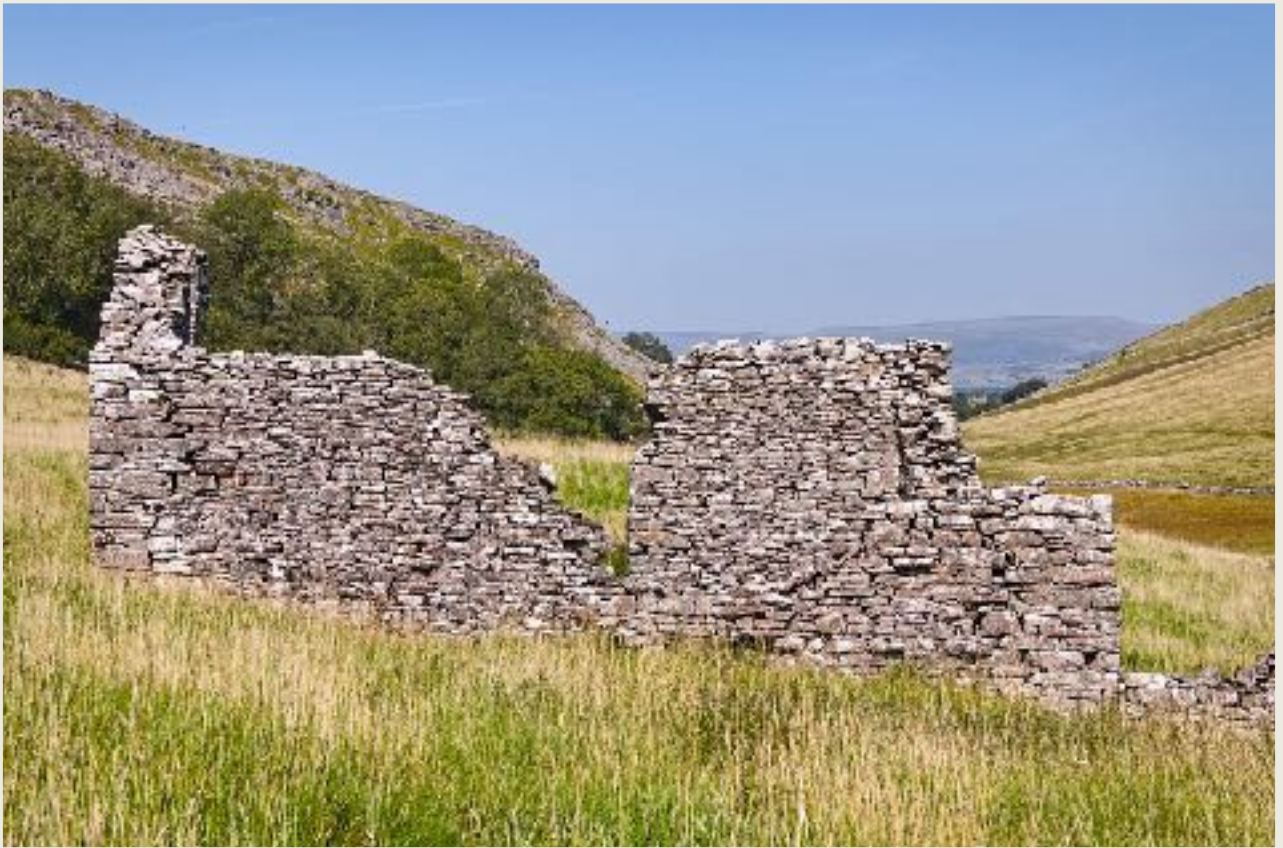
South elevation, with no apparent doorways (top); North elevation with remains of cart entry (bottom).

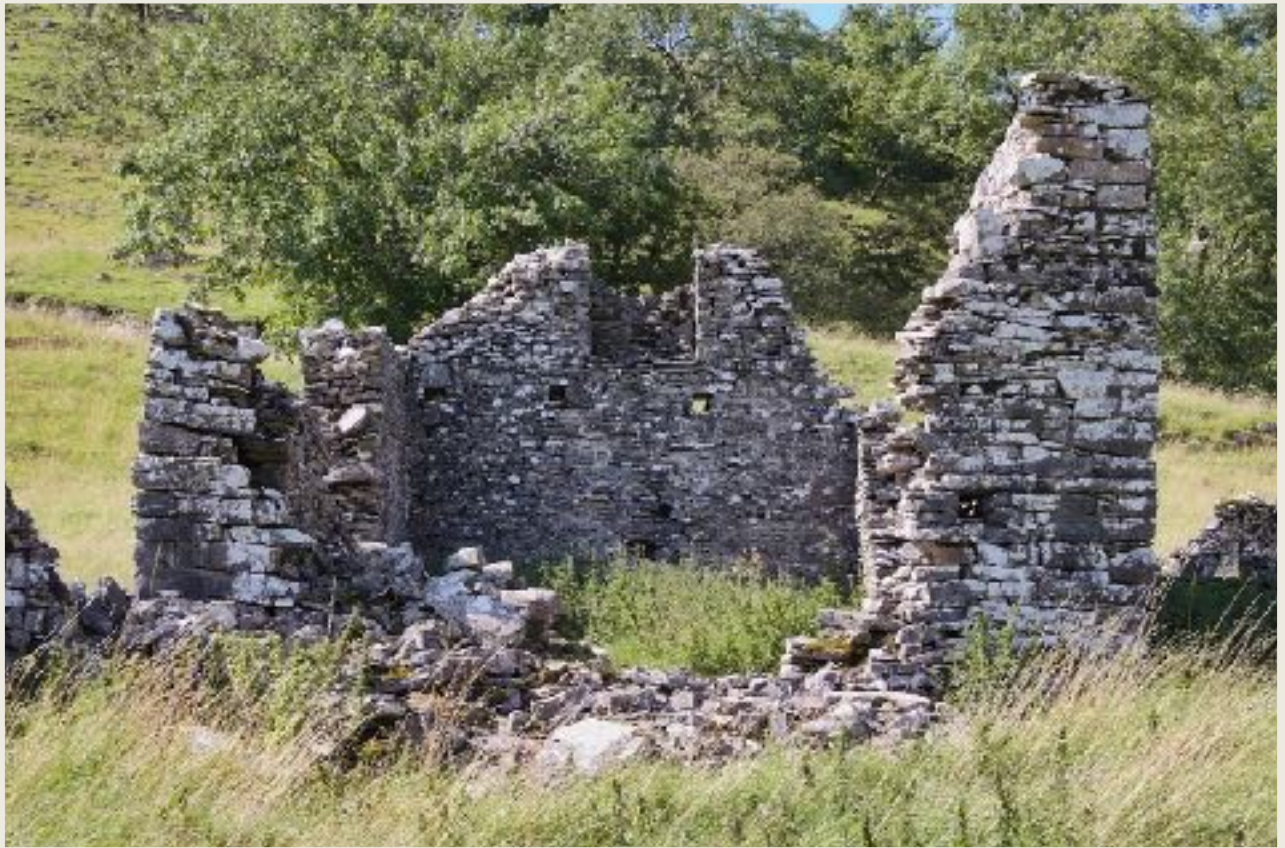
East Gable

East gable, substantially lost. The unusual construction and steep terrain make it unlikely that there were any openings beyond putlogs and ventilation.

At the eastern end the ground levels fall away sharply, prompting the builders to construct the east gable in a tiered or abutment style. Bank barns don't usually include this feature, which would make constructing openings difficult. The decision to do so may reflect the limitations of dry-building.

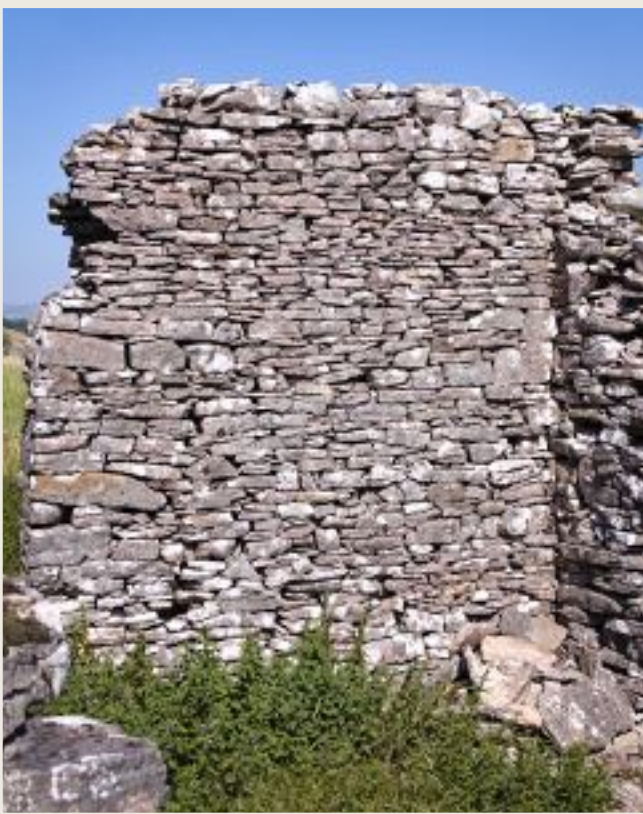
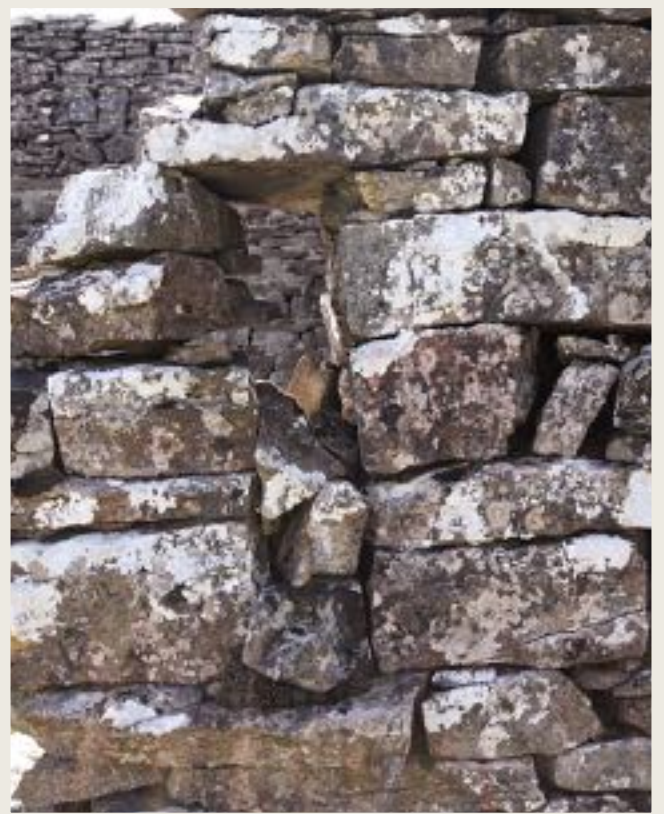
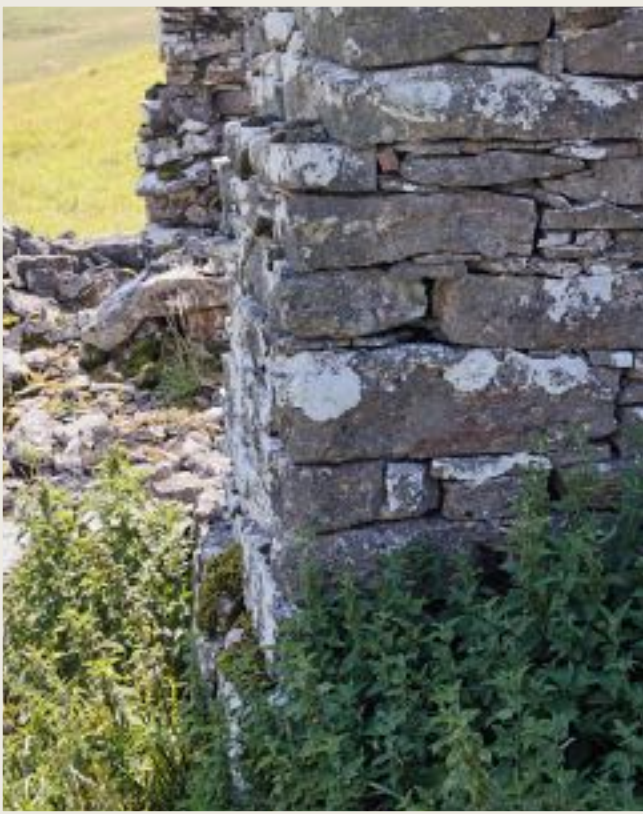
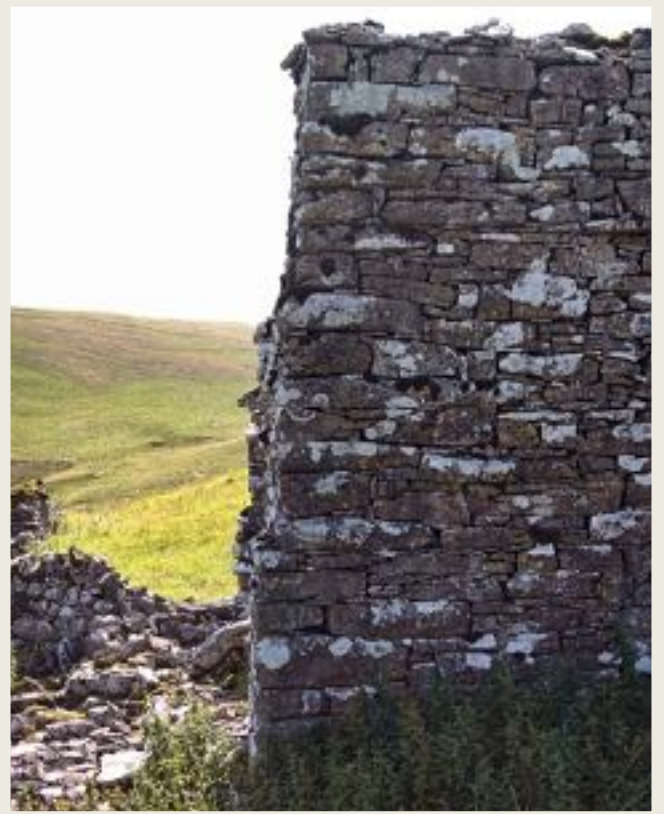
(Top Left) Interior view of north wall, displaying no signs of former timbers or divisions; (Top Right) ventilation slit in north elevation; (Bottom Left) Detail of stepped construction of east gable; (Bottom Right) full profile view.

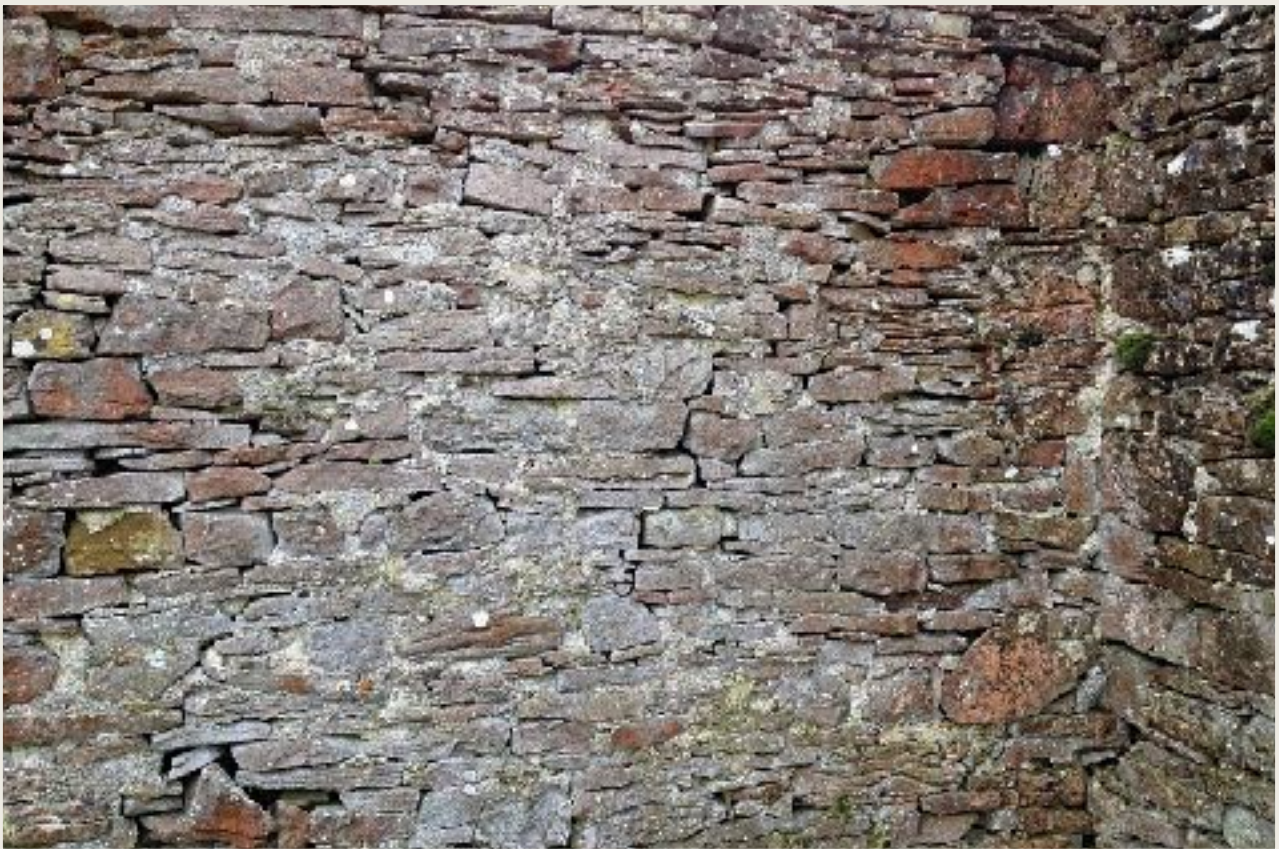
View of south elevation interior showing well mortared wall brought flush or rendered with a harl-like finish.

The decision to mortar the internal face in this instance is unlikely to be for structural reasons. More likely it was for cleanliness and moisture control. A purely dry-built build would provide good ventilation (important for storing hay), but this is easily provided by ventilation holes. On the other hand, the crevices would soon accumulate dirt and be a ready home for vermin. Using mortar solves this problem, and would facilitate in taking up excess moisture during less windy periods.

It appears that the walls were originally well straightened either by dubbing out or harling (locally termed 'wet-dashing'). However, surviving fragments of limewash appear

to have been applied to a much less regular surface. This may indicate a period of neglect; after which the interior was cheaply limewashed.

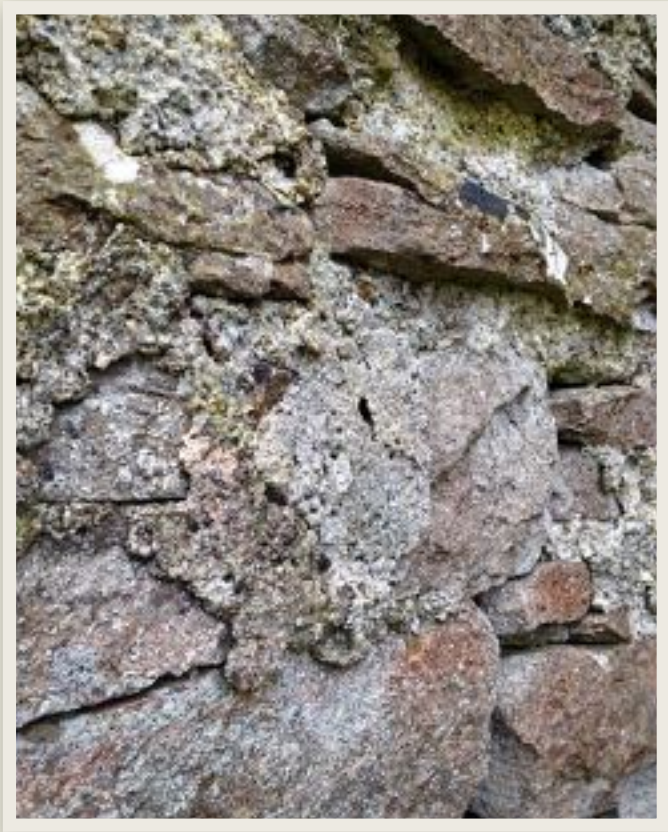
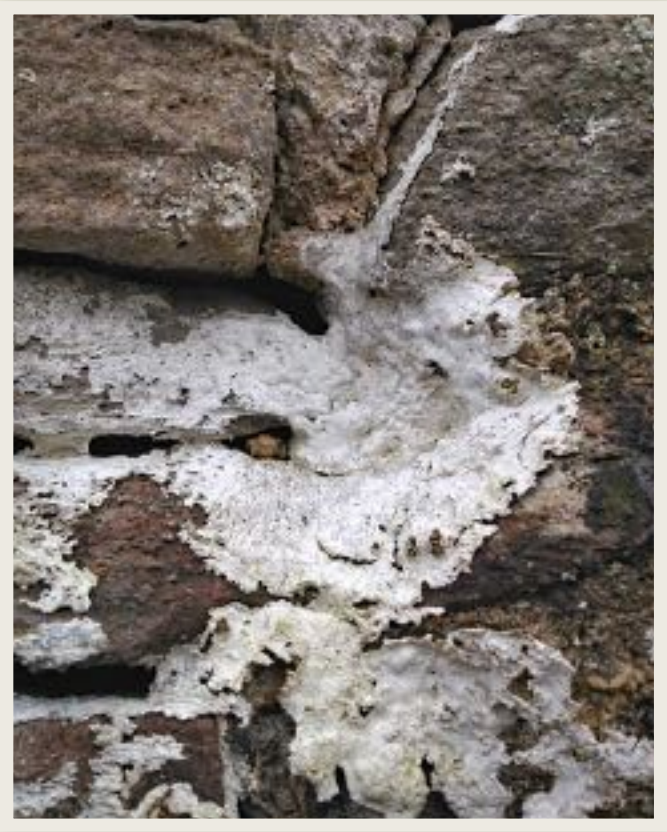
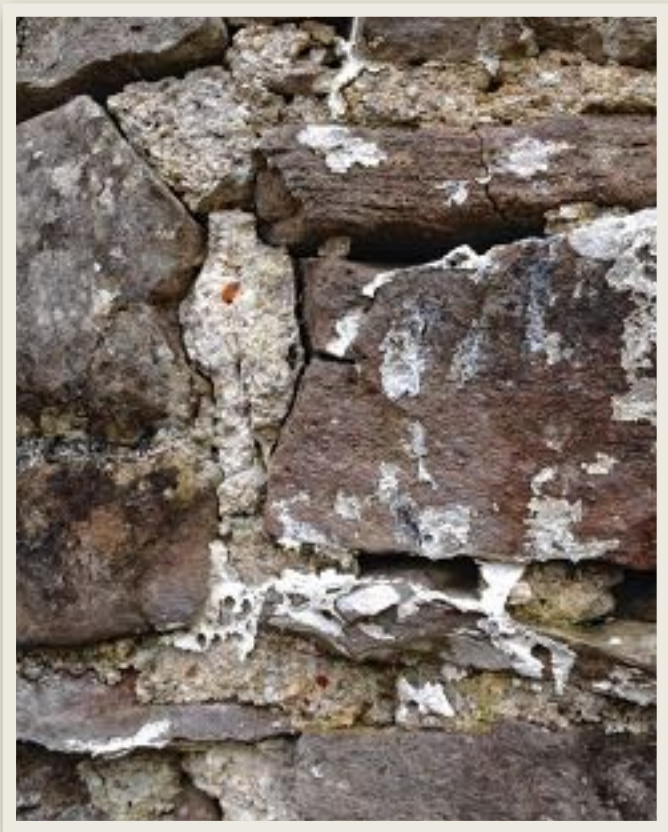
Externally, the surviving dry-built walls are in good condition, with structural issues caused by the loss of integrity of the building as a whole (rather than deterioration of the fabric). Measures to conserve the internal mortars are unlikely to majorly benefit the remaining structure, and would be done so for their own historic value.

(Top left) Remnants of render-type finish on interior wall, possibly harled (top right & bottom left) remnants of limewash, evidently applied to mortars that were already recessed or eroded.
